# **APDES Inspection Report**

**Permit # AKR06AC70**

**Stabler Point Rock Quarry**

**August 17, 2016**

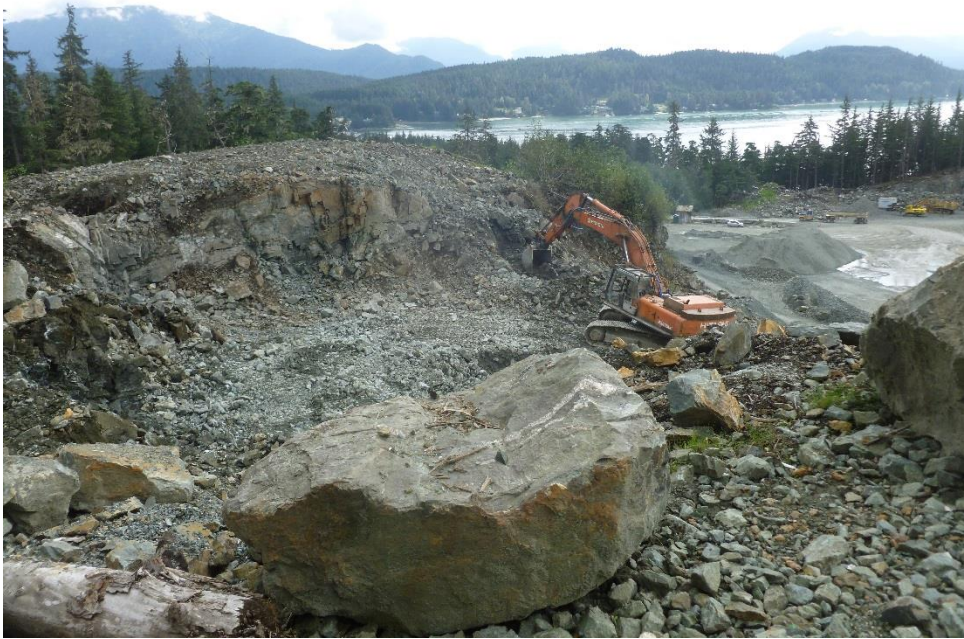
I inspected the upper property boundary (**Photo 1**) and the and lower portion of the quarry (**Photo 2**) near the entrance and scale shack. Stormwater pools in the lower area and drains via gravity to a series of settling ponds (**Photo 3**). Flow from the settling ponds drains along the west side of the paved access road to another settling pond (**Photo 4**) on the north side of Glacier Highway. I followed the flow path to a sump (**Photo 5**), which discharges to Auke Nu Creek before the creek flows under Glacier Highway to Auke Bay. Mr. Venechuk said that most stormwater from the quarry infiltrates into the ground. He said that he has not observed a discharge to Auke Nu Creek in the few months that he has managed the quarry.

**Photo 1 / P1020490** – Southeasterly view of the upper portion of the quarry

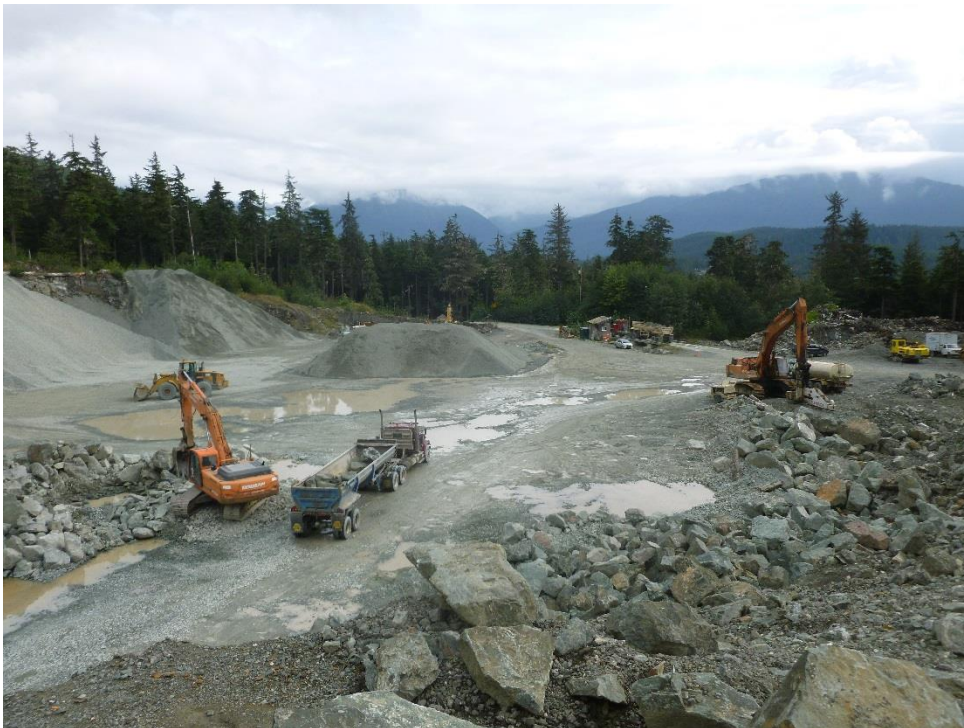
**Photo 2 / P1020482** – Southeasterly view of the lower portion of the quarry

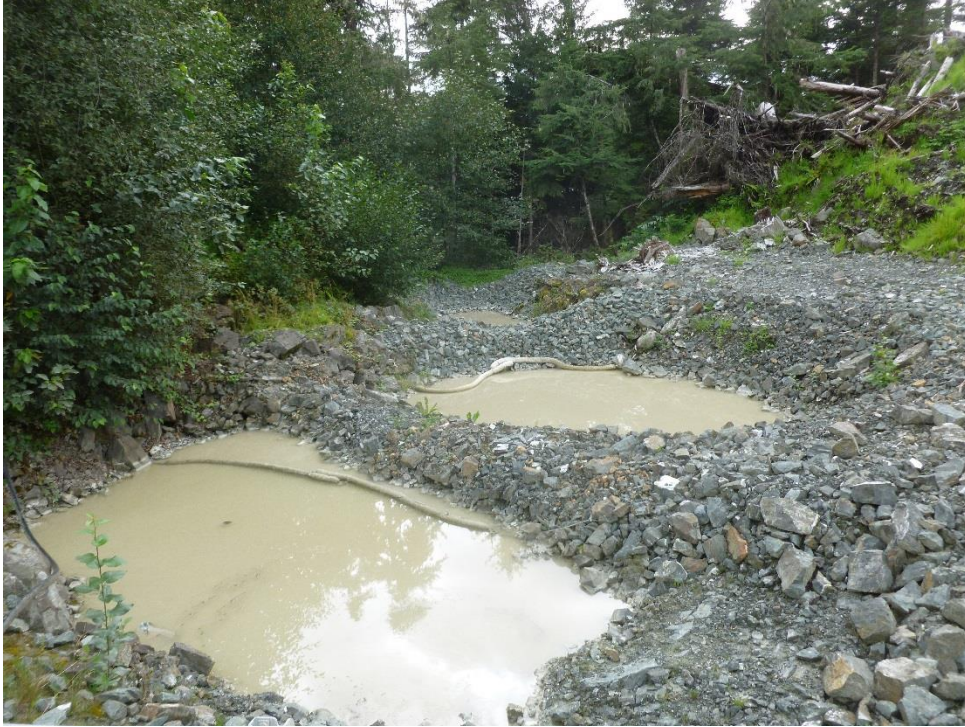
**Photo 3 / P1020477** – Southeasterly view of settling ponds on the south side of the scale shack

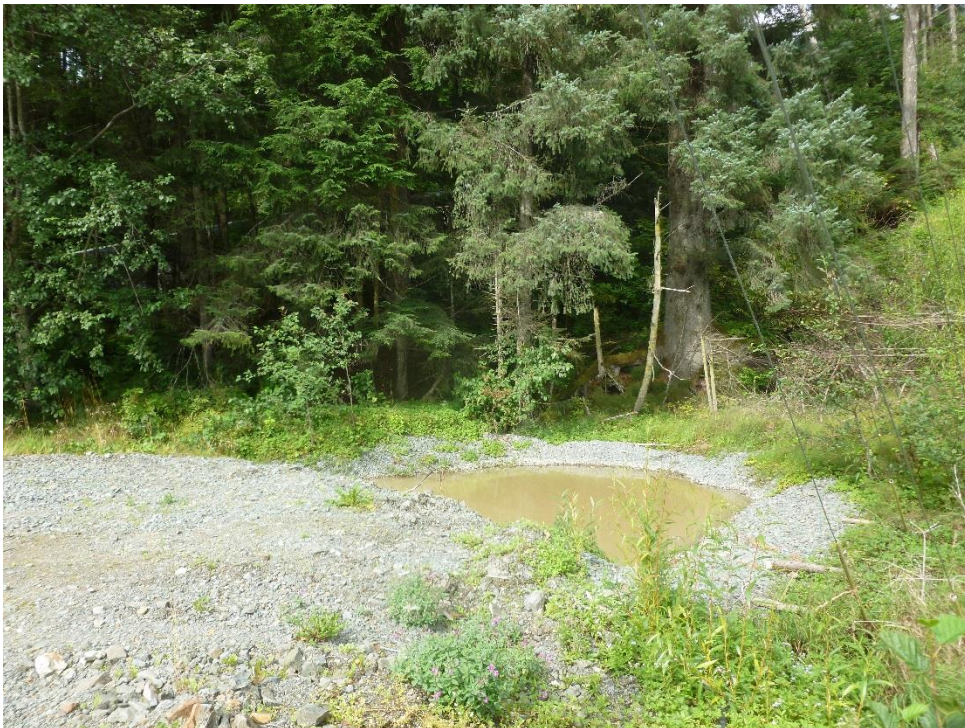
**Photo 4 / P1020486** – Settling pond on the north side of Glacier Highway

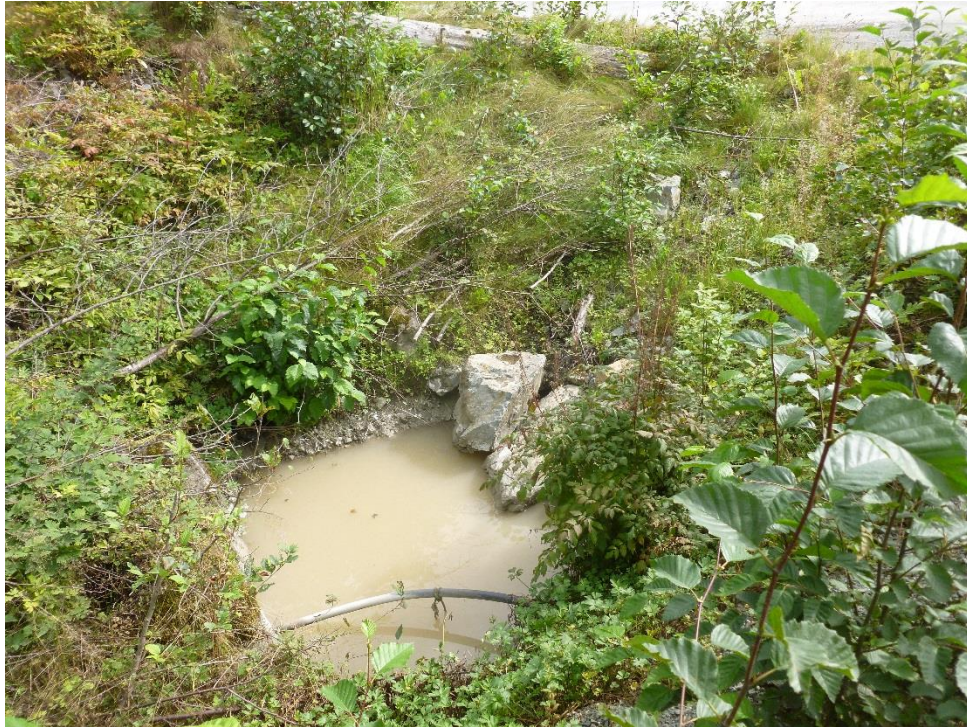
Mr. Venechuk said that he has not observed a discharge from the final stormwater collection sump (**Photo 5**), in the few months that he has been the quarry manager. He said that if discharge does not occur during a monitoring period, he will collect a sample of the accumulated flow inside the sump. Consequently, Mr. Venechuk said that the facility has reported exceedances of the benchmark for total suspended solids (TSS) during periods of no discharge at the facility. For example, I noted that monitoring records from July 2016 indicated 150 mg/L of TSS, which exceeds the TSS benchmark of 100 mg/L in Section 11.J.8 of the MSGP. However, Mr. Venechuk said this result was not representative of an actual discharge to Auke Creek.

**Photo 5 / P1020487** – Easterly view of the final stormwater collection sump, which discharges to Auke Nu Creek

I advised Mr. Venechuk to ensure that DMR values are representative of actual discharges to receiving water and if no discharge occurs during a monitoring period, the facility should report “no discharge” on the DMR.

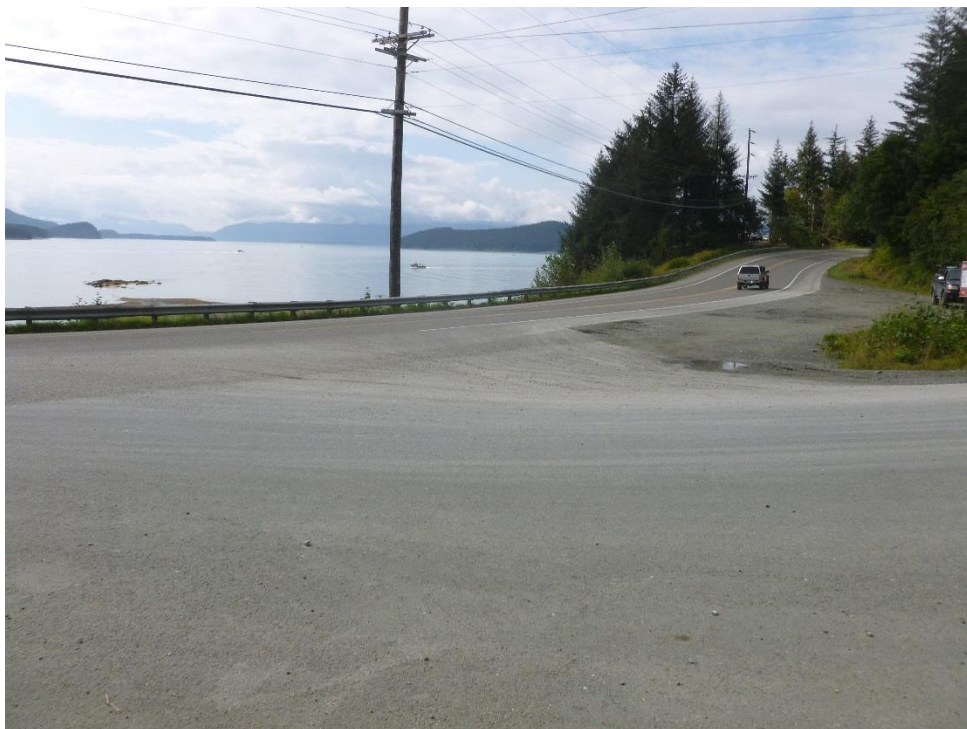
On Glacier Highway I observed track-out from the quarry access road (**Photo 6**). Mr. Venechuk said that the quarry's street sweeper (**Photo 7**) is no longer in use, but the CBJ periodically sweeps the shoulder of the highway.

Section 11.J.4.2.5 of the MSGP states that “a permittee must provide an effective way of minimizing off-site vehicle tracking of sediment from wheels to prevent track-out onto paved surfaces.”

During the inspection, I observed track-out from the quarry access road onto Glacier Highway (**Photo 6**). I asked what practices are in place to prevent track-out and Mr. Venechuk said that the facility plans to install a cattle guard at the quarry entrance. He also said that quarry’s street sweeper (**Photo 7**) is no longer in use, but the CBJ periodically sweeps the shoulder of the highway.

**Photo 6 / P1020489** – View of track-out from the access road to Glacier Highway

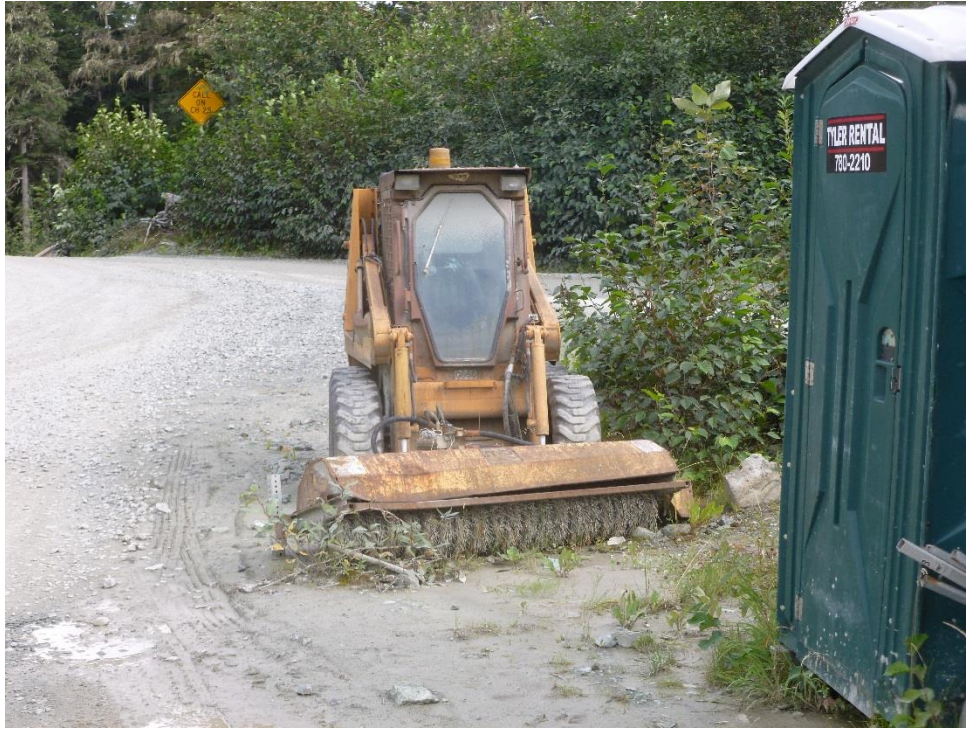
**Photo 7 / P1020494** – Street sweeper, no longer in use
